Field Report for Airborne Data Collected In Support of US EPA Region 6 Intercontinental Terminals Company LLC Fire 31 March 2019

Data Results Flight 16, 31 March 2019

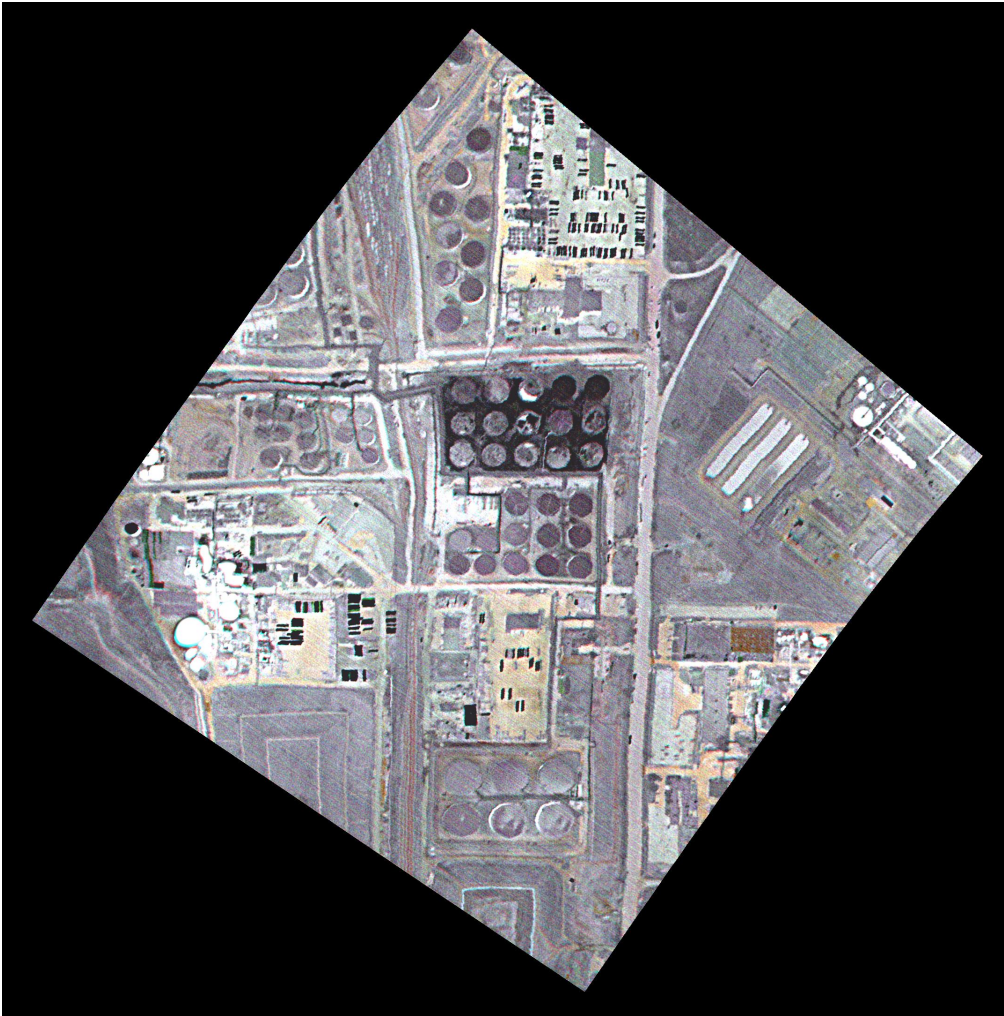
A total of 1 test and 7 data passes were made in the proximity of the impacted tank farm and also in extended areas surrounding the site and infrared line scanner images were generated for each pass. Figure 3 shows a typical 3-band infrared image obtained from data collected for Run 3. IR imagery of the tank farm indicates that all tanks are at ambient temperature with tanks in the NE corner of the farm being the coolest. A thermal image of the tank farm for the same pass confirms this observation.

Figure 3: IR image of ITC data for 31 March 2019, Flight 16 Run 4

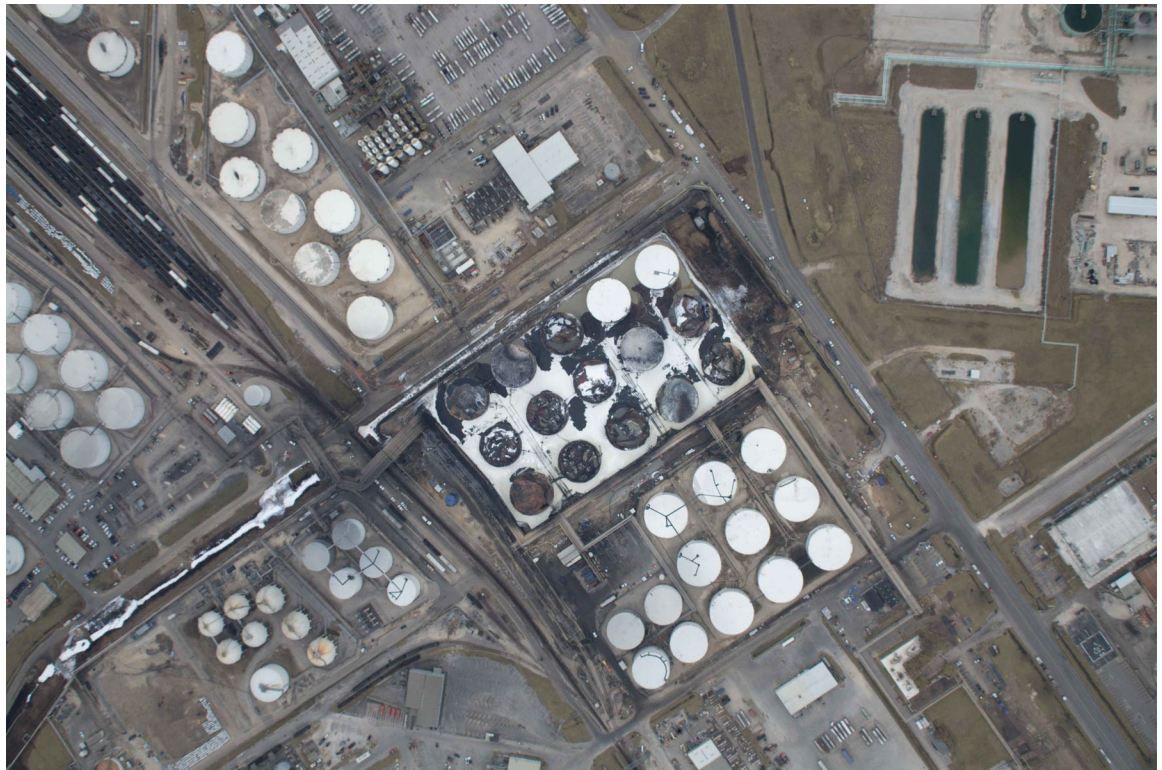
A full set of high resolution aerial digital photography was collected as part of the flight. Figure 6 shows a representative overhead image collected as part of each pass over the tank farm. Analysis of the image shows that several of the tanks appear to have the tops removed. An oblique image of the tank farm confirms that 6 of the tanks appear to have the tops and sides removed.

Figure 6: Aerial Image of the Tank Farm, 31 March 2019, Flight 16

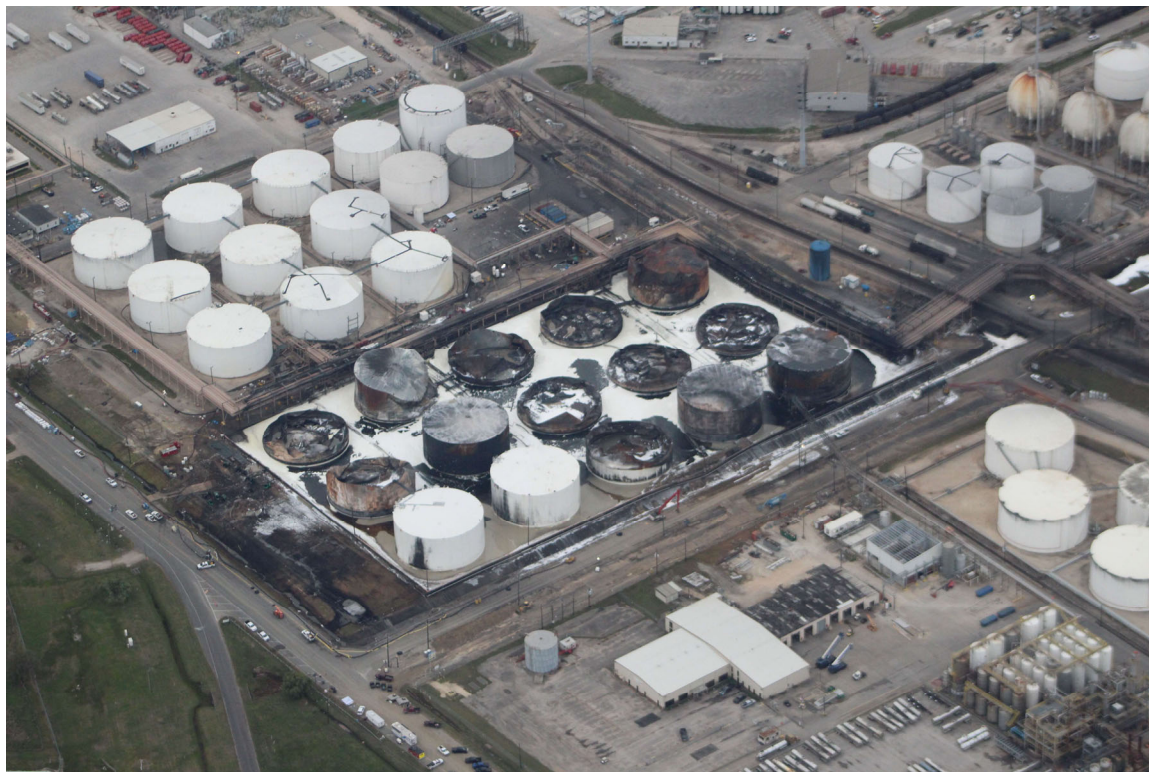
Figure 7: Oblique Image of the Tank Farm, 31 March 2019 Flight 16

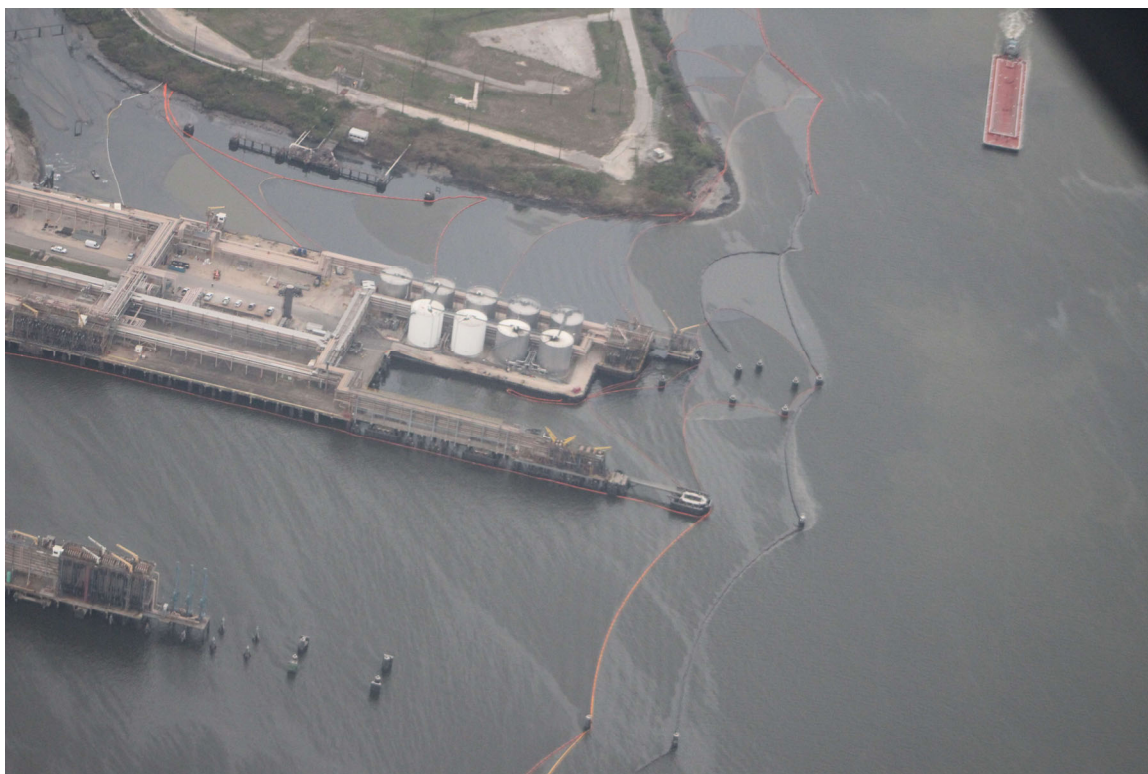
An aerial image of the confluence area is shown in Figure 7. Note that the image is darker due to high level cloud cover. Numerous booms can be seen in the confluence area with trapped product in each boom pocket. A small amount of sheen can be seen in the lower left area of the ship channel boom. An oblique of the same area confirms the presence of trapped material in the boom structure with sheen pushed up against the ship channel booms by the wind (Figure 8).

Figure 8: Oblique Image of the Ship Channel Boom Area, 31 March 2019, Flight 16
